| Car Number | Chassis Number |
| F24-I96 | NHW20-0085319 |

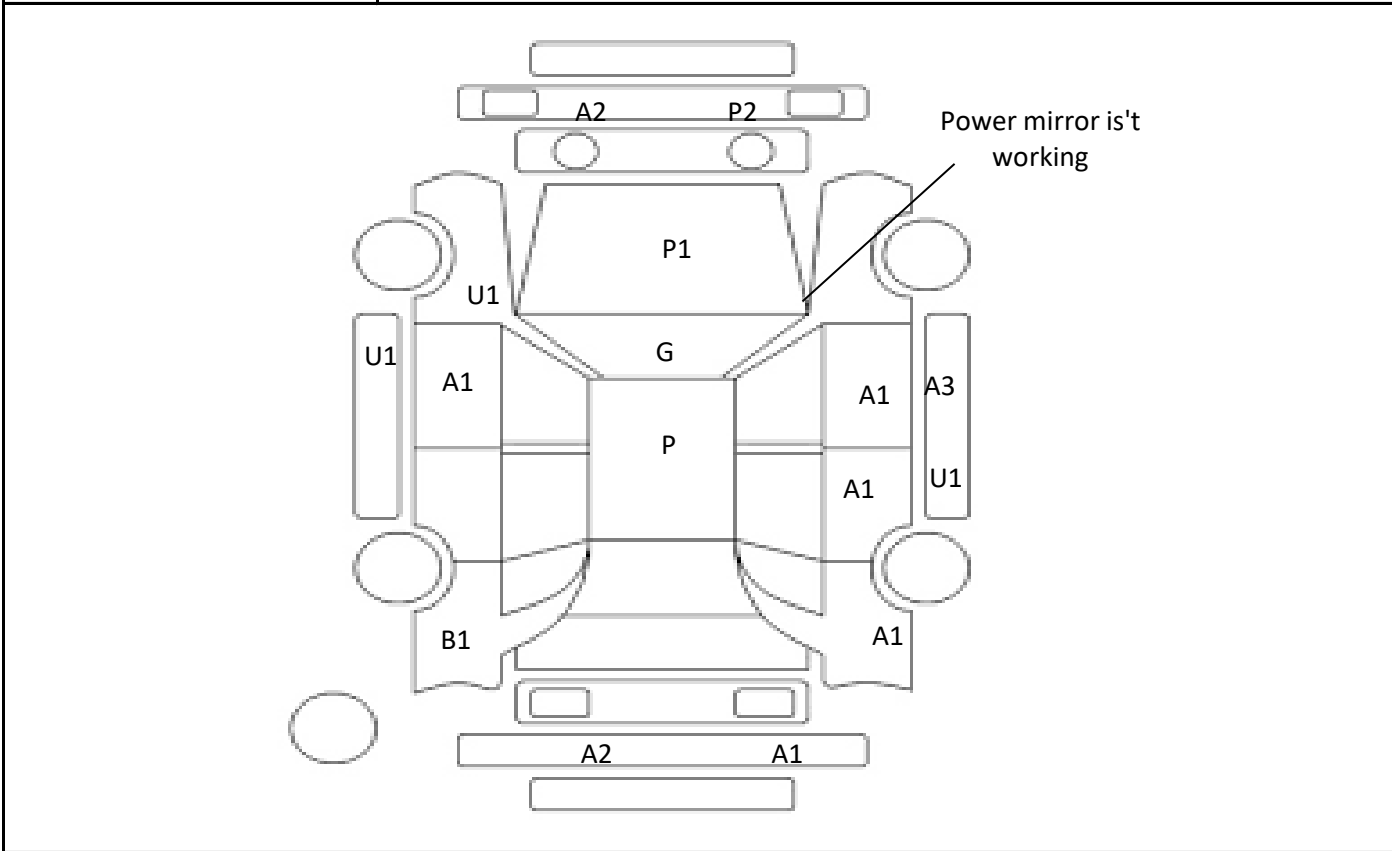
(Remark)
Right side power mirror isn't working
